RESEARCH AND DEVELOPMENT  
REPORT NO. 24

EXPERIMENTAL PAVED SHOULDERS  
ON  
FROST SUSCEPTIBLE SOILS  
(IHR-404)

EXPERIMENTAL PAVED SHOULDERS ON  
FROST SUSCEPTIBLE SOILS  
IHR-404  
INTERIM REPORT NO. 1

December 1969

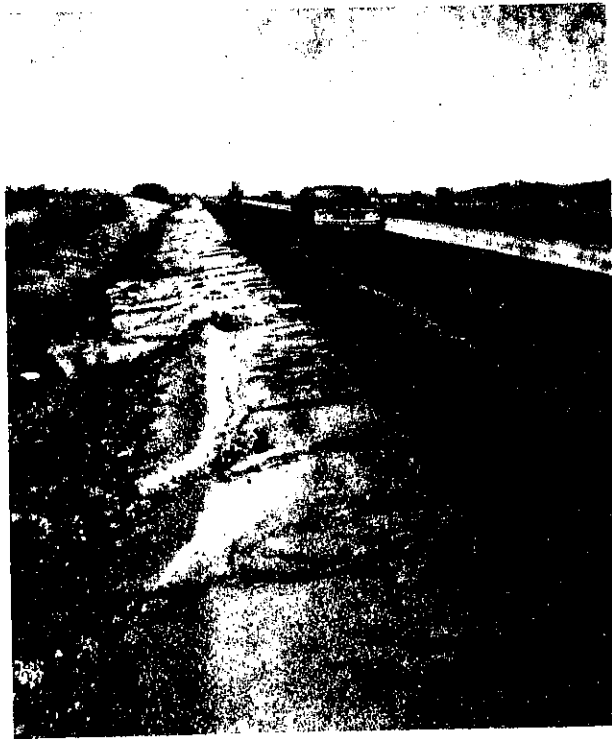
Figure 6. Type A aggregate tended to saturate with rainfall and wash badly during rains.

The washed sand that was furnished to meet the Type A subbase material specification was difficult to compact. It supported the compaction equipment when moistened, but after drying lost its density when disturbed. It was

especially troublesome in the median shoulders where it gave way under the 4-foot rollers and allowed them to tip sideways. As mentioned earlier, the Type A material also washed badly during rains, and required reworking before placement of the next structural layers.

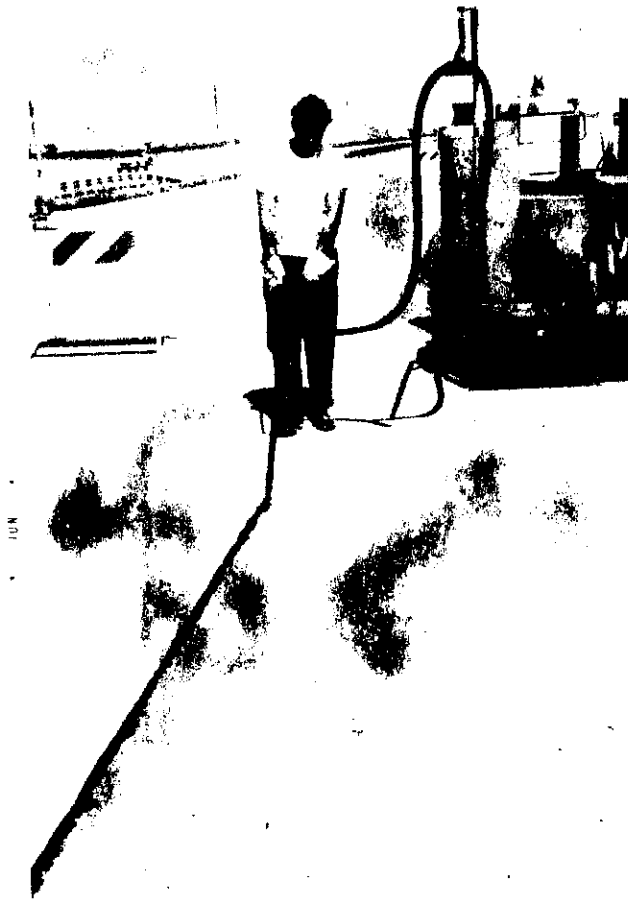
Figure 14. Sawed joints in west half of each test section were sealed with a hot-poured elastic sealant.

joint, is shown in Table 11 for the April 1969 survey. It can be concluded from the data presented in this table that sealing the pavement-shoulder joint was effective in reducing the amount of longitudinal cracking near this joint in the PAM and CAM materials, but was not essential in the BAM and PCC materials where this type of cracking has not developed. Sealing will be seen not to have been totally effective in the PAM and CAM shoulders where some cracking has developed in the sealed areas.

The hot-poured rubber-asphalt joint sealant is retarding the development of longitudinal cracking at the pavement-shoulder joint of the CAM and PAM sections. It has had no measurable effect on the behavior of the BAM and PCC shoulders up to the present time. More experience is needed before any possible beneficial effect when used with BAM and PCC shoulders can be determined.

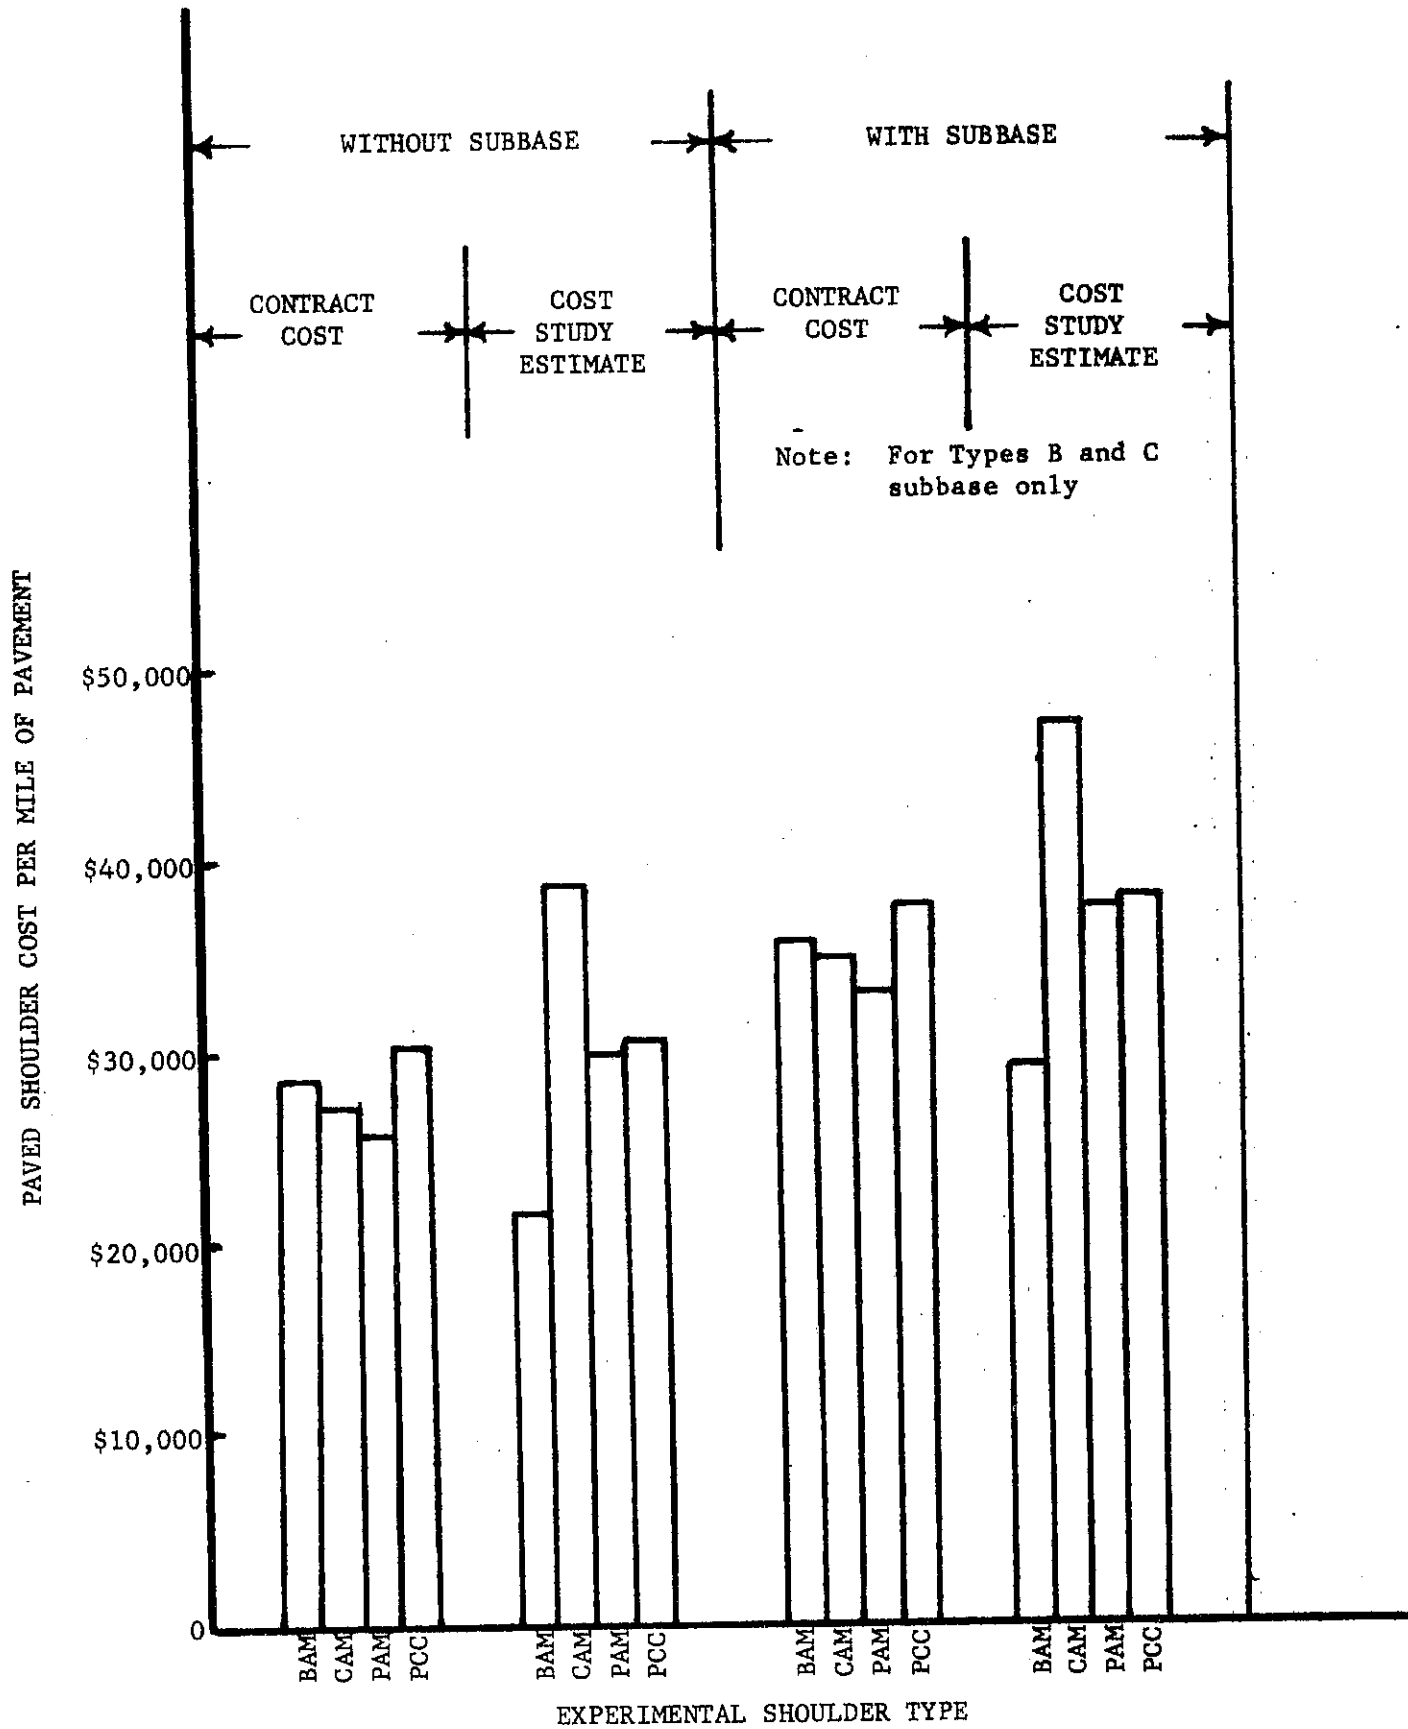
The principal results of the analyses are shown in the bar chart of Figure 15 developed from costs summarized on a per mile basis for shoulders adjacent to one pavement. It is emphasized that the per mile costs that are shown for the various shoulder designs and types must be recognized as applying to experimental construction, and in some instances to types of construction unfamiliar to the contractor. Under these unique conditions, the cost figures and cost relationships that are indicated may not be truly representative of conditions that might exist in normal situations.

It will be noted also in the figure that the use of Types B and C (coarse aggregate) subbases adds about \$7,000 to \$8,000 per mile to the computed construction costs. The cost of the Type A (sand) subbase that proved to be impractical because of construction problems was higher than that for the Types B and C subbases, and was not included in the development of the chart.

Figure 15. Shoulder construction costs on experimental project

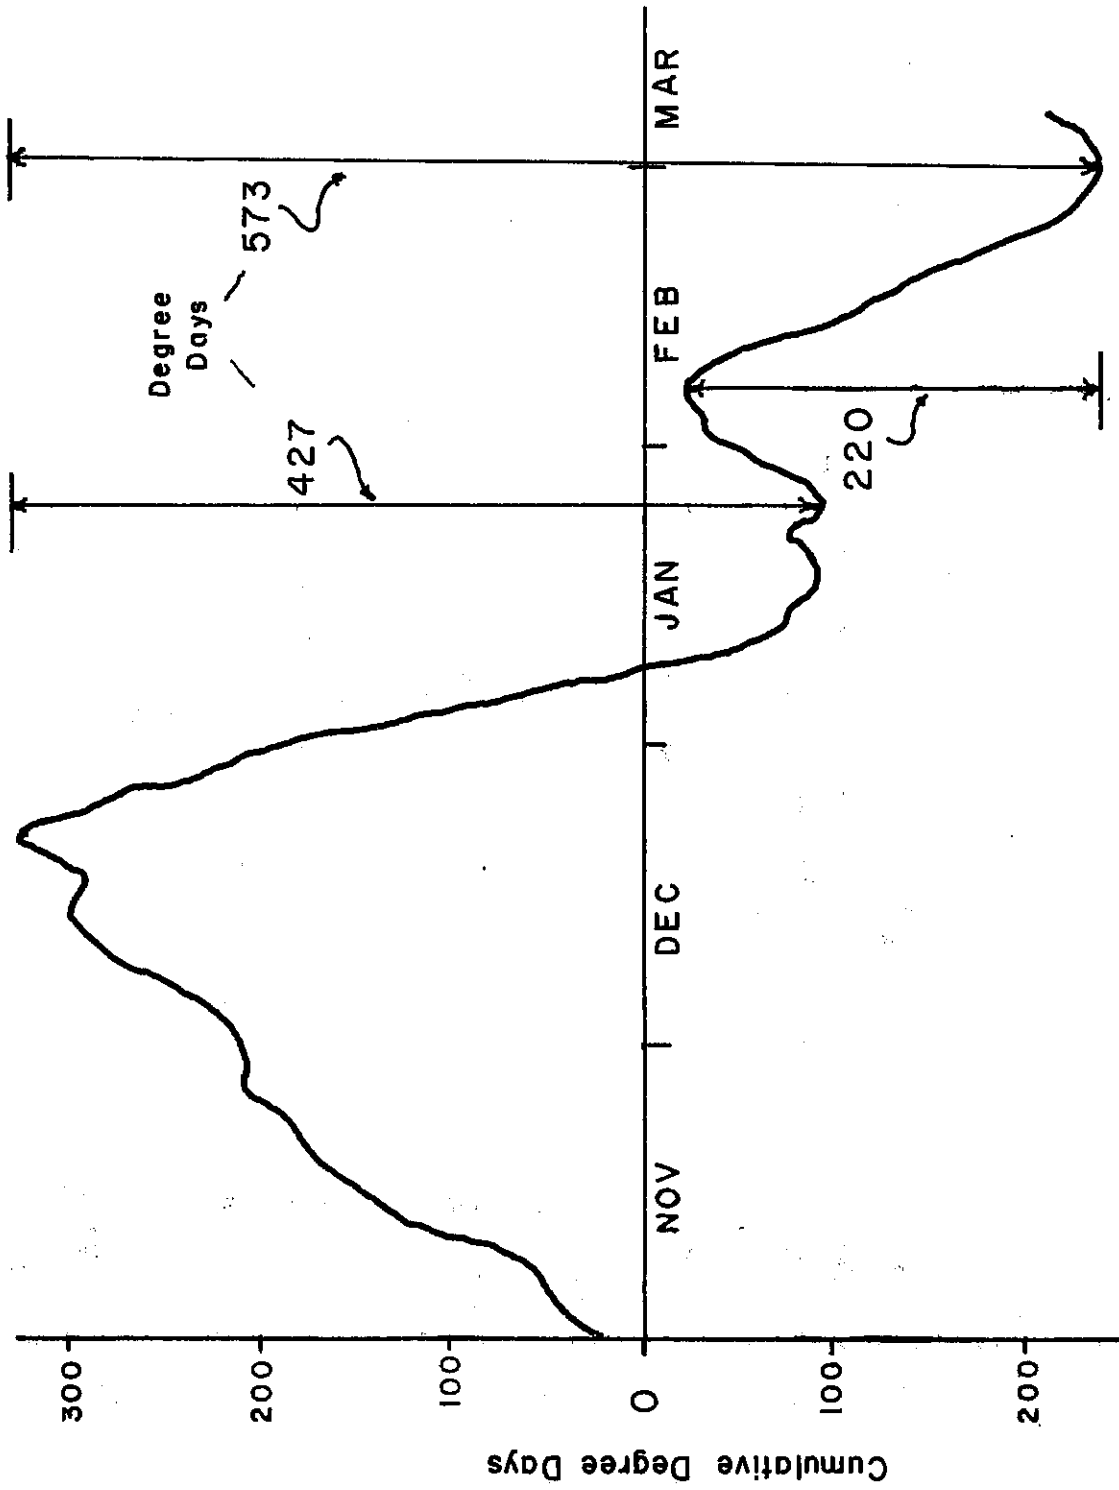
It will be seen in Figure 18a that two distinct freezing cycles occurred during the winter of 1967-68. The first freeze produced 427 freezing degree-days, and the second produced 220 freezing degree-days. The net total for the winter was 573 freezing degree-days. In the period between the two freeze

FIGURE 18a. Freezing Index for Joliet, 1967-68.

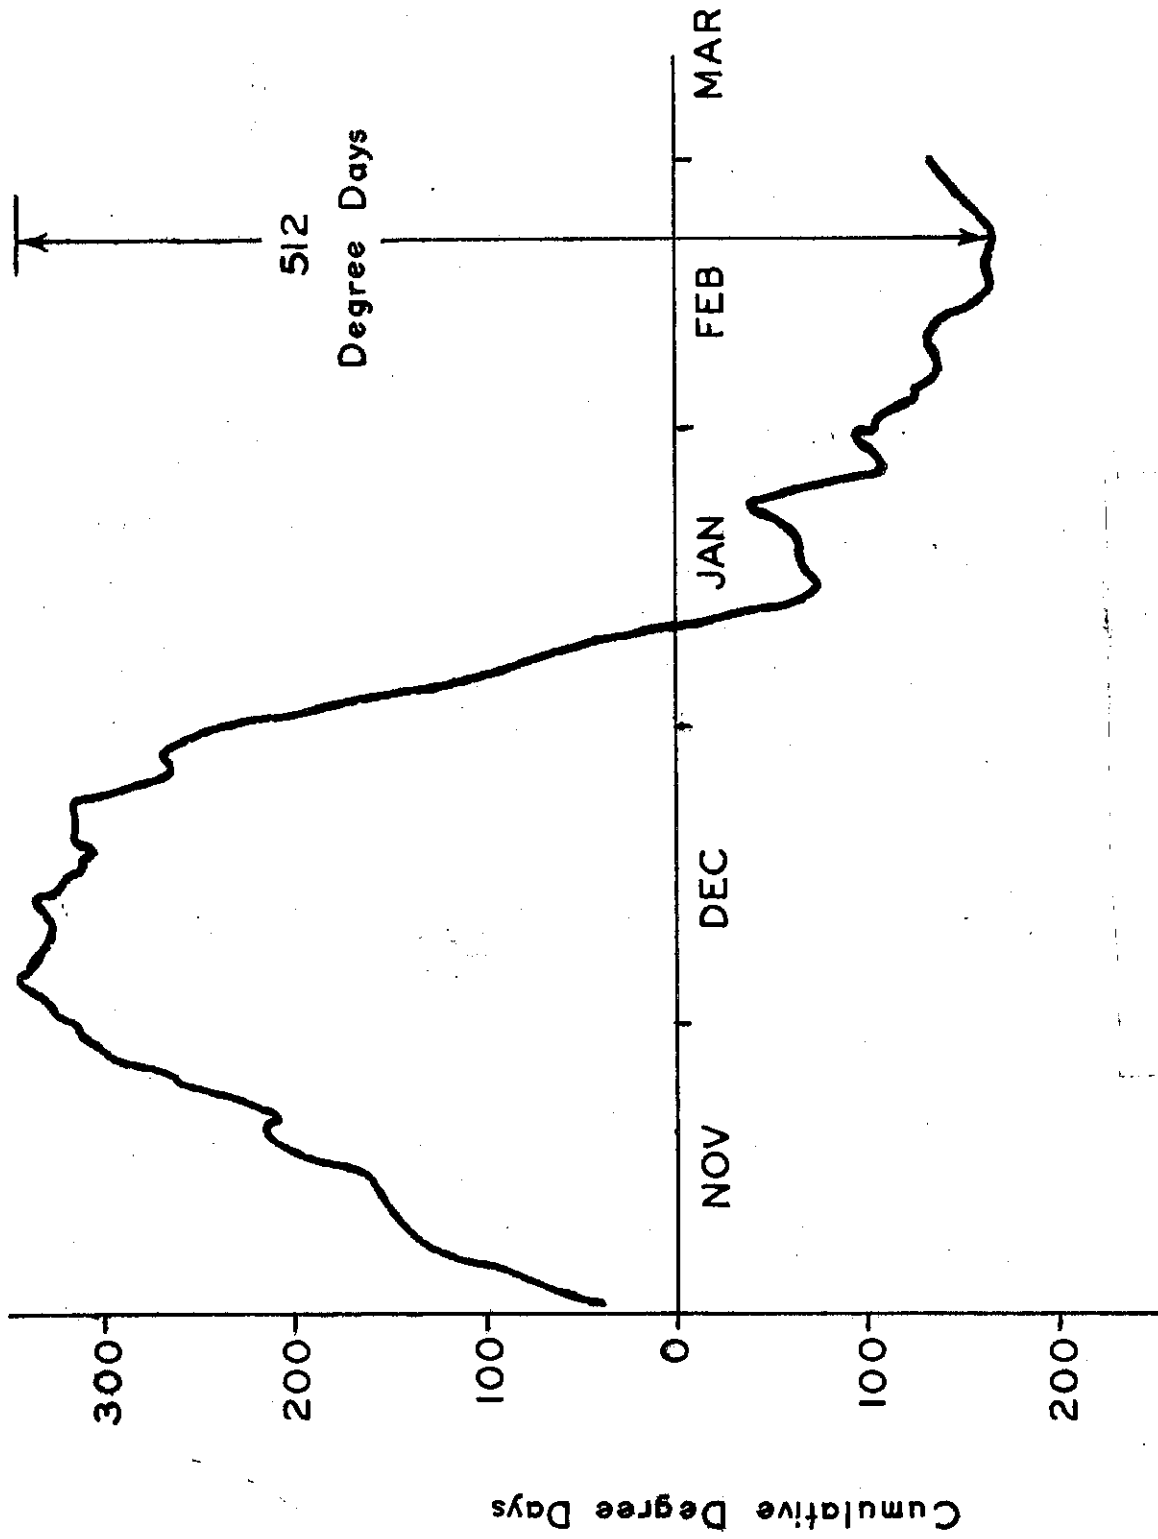
FIGURE 18b. Freezing Index for Joliet, 1968-69.

cycles during late January, frost was indicated by the gages on the project to have totally disappeared at Stations 495+00 and 548+00, but not at Station 626+00. It will be seen in Figure 18b that only one major freeze cycle occurred in 1968-69, producing 512 freezing degree-days. Frost was present continuously in the embankment soils at the frost gage sites from December 1968 to March 1969. Measured frost depths at each of nine locations are shown in Table 6 for the three major freeze cycles that have been noted thus far. It will be noted that at Station 626+00, where frost did not completely disappear during the January thaw in 1968, frost depths were greater than at the remaining stations during the second freeze cycle. It will also be noted that differences in frost depth occurred between locations for a given number of freezing degree-days. These differences probably are associated with differences in pavement and shoulder type, and with the microclimate at the individual sites.
